Subject: Inspection Reports – UPDES Permit No. UT0024368 (Crandall Canyon Mine)

UPDES Permit #: UT0024368 – Genwal Resources Crandall Canyon Mine
Inspection Type: Reconnaissance Inspections + Compliance Sampling Inspections
Inspection Dates: July 28 and August 4, 2009
Weather Conditions: Sunny and warm, ~ 80 °F.

Genwal RI+CSI 7-28-09 (UT0024368)

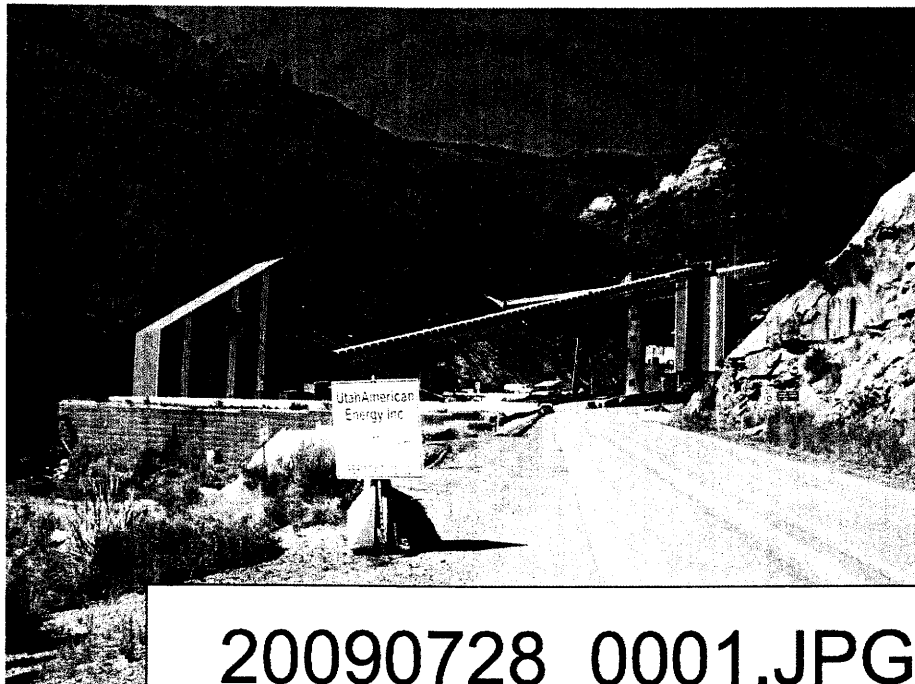
20090728_0001.JPG

Photo Number	File Name	Description	Date/Time	Photographer
0001	20090728.jpg	Entrance to Genwal Resource's Crandall Canyon Mine	7-28-09 (am)	J. S. Stodette
0002		Seed pond & outfall 001		
0003		outfalls to Crandall Creek		
0004		Crandall Creek proximal to 002		
0005		New Piping for Iron treatment works		
0006		Iron treatment works & basin		
0007		Facing west from Iron treatment basin		
0008		Crandall Creek upstream		
0009		Flow meter (002)		
0010		Flow meter location for 002 flows		
0011		Downstream Crandall Creek		
0012		Downstream further along Crandall Creek		
0013		Crandall Creek just prior to confluence w/ Huntington Creek		
0014		Close up of Crandall Creek just prior to confluence		
0015		Crandall Creek just prior to confluence		
0016	✓	Huntington Creek w/ Crandall Creek confluence		✓
END
